Observations of anomalies in diaphragm walls for deep tunnel excavations

W. Maekelberg

Geotechnical design engineer, TUC RAIL n.v. Belgium

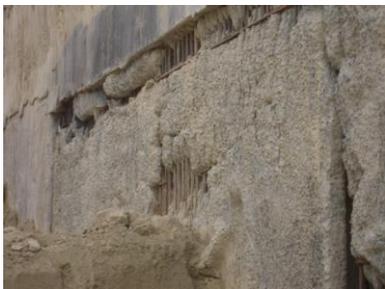
Figure 1: Bentonite/sand-inclusion¹ in diaphragm wall panel

The bentonite/sand inclusions in the diaphragm wall panels are more or less horizontal with an observed difference in level of 20 to 30cm (see figure 1 and figure 3). Some bentonite/sand inclusions in joints between the diaphragm wall panels have been identified over the full thickness of the wall (see figure 3).

The bentonite/sand inclusions identified in the diaphragm wall panels were created by a combination of two phenomena:

As the fluidity of the concrete in the upper meters decreases, the upwards movement of the latter becomes more and more difficult during the concreting process. Once the resistance of the concrete to pass along the outer surface of the tremie pipe becomes less than the resistance to move all the concrete above the bottom of the tremie pipe upwards, a breakdown along the tremie pipe occurs [4]. This generates a fresh concrete on top of the original concrete surface in which the bentonite slurry with increased density becomes embedded and a bentonite/sand inclusion may be created.

The decrease of the fluidity of the concrete during the concreting is caused by beginning of the binding process of the concrete. Furthermore the concrete in the upper meters scrapes the bentonite cake on the walls of the excavation. In absence of the enclosing layer, a dewatering of the concrete can occur, resulting in a further decrease of the fluidity.

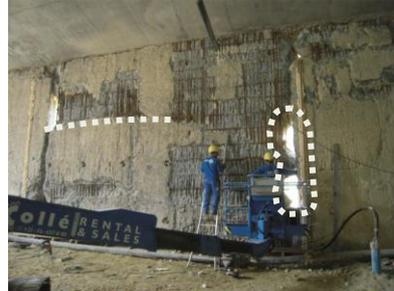
Figure 3: Bentonite/sand-inclusion in joints over the full thickness of the diaphragm wall panel

The bentonite/sand inclusions occurring in joints between the panels have a similar origin as described above. Near the joints, the flow of the concrete is further inhibited by the presence of the waterproofing strip. By placing the reinforcement cage too close against the waterproofing strip, this resistance is further increased. Due to the increased resistance on the sides of the panel, a higher gradient in the concrete surface can be observed during concreting. As a concrete breakdown along the concreting pipe occurs, the bentonite slurry with increased density is dragged with the flow of the concrete, causing a bentonite/sand inclusion in the lower parts of the concrete surface on the side of the panel.

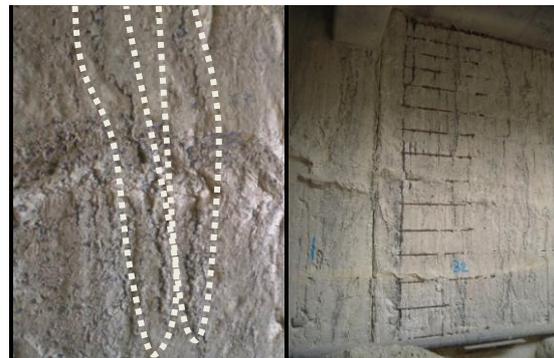
Besides of the bentonite/sand inclusions, also bleeding channels as shown in figure 4, have been observed, as well as an inadequate concrete cover. The bleeding channels are superficial with a depth of a few cm. and can be recognised by their washed out delineation. Since no cores through the panels were made, no bleeding channels have been investigated deep inside the diaphragm wall, as identified in [3].

Figure 4: Bleeding channels on the concrete surface and inadequate concrete cover

Bleeding is caused when a very high pressure exists in the laitance of the concrete and this laitance is pressed through the still liquid concrete. A similar effect can also be caused by the water present in the bentonite/sand inclusions. This water being under pressure may, in an upward motion, flow through the fresh concrete and wash out laitance from the concrete. However, no link was found between the occurrence of the bleeding and present bentonite/sand inclusions.

The inadequate concrete cover on the reinforcement cage of the panel is mainly caused by the use of spacers which are not adapted to the soil in which the diaphragm wall panels are made. For the Diabolo project, the diaphragm wall panels were dug through sand with sandstone banks [5]. By digging through the sandstone banks local widening of the trench occurs. If the spacers are installed in such overwidth, they are inefficient. It is also found that asymmetrical reinforcement cages are being pushed during concreting to the side with the greatest reinforcement concentrations. On this side, the flow of concrete through the reinforcement is

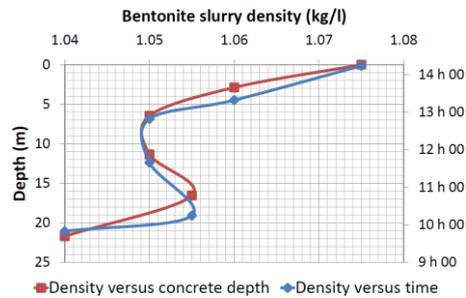
Figure 5: Evolution of the bentonite slurry densities during concreting of panel G137

The starting value of the bentonite slurry density was 1.04kg/l. This value was measured at the beginning of the concreting of the panel. As the concreting progresses a slight increase in the density of 1.05kg/l can be observed. Towards the end of concreting as the concrete surface is at 3m depth from ground level, a significant increase in the density is observed.

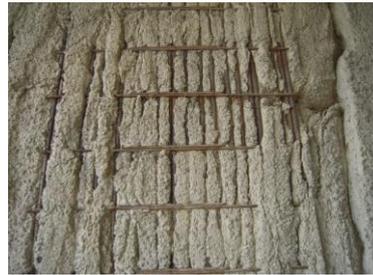
much more difficult, resulting in a lateral force on the cage. This movement reduces the orifice between the trench wall and the reinforcement cage which makes the flow of concrete even more difficult. This phenomenon may also lead to the occurrence of bentonite inclusions, such as visible in figure 6.

Figure 6: Inclusions caused by the lack of concrete flow
