Diaphragm walls, a reliable solution for deep excavations in urban areas?

A. Frits van Tol, Deltares, Delft University of Technology, Delft, Netherlands

This paper describes some cases in which the quality of the D-walls failed to meet the requirements and analyses the most probable reasons. The authors discuss the lessons learnt and the measures needed to restore confidence in D-walls.

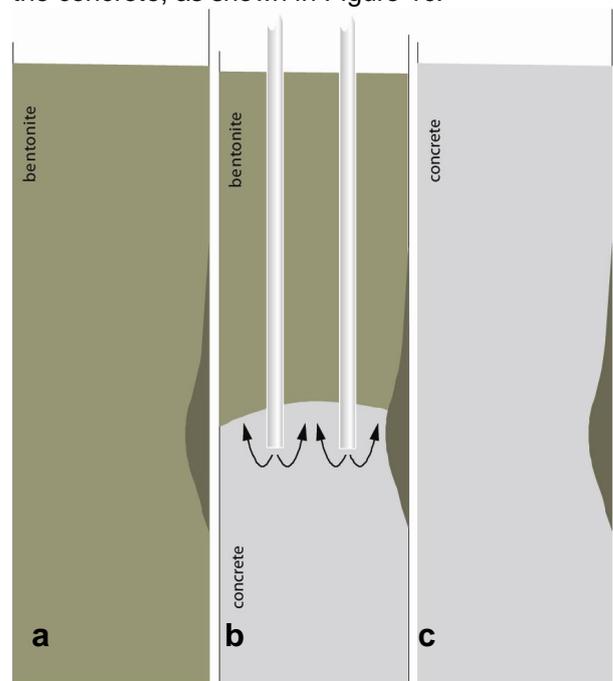
Unfortunately, the precise cause of the bentonite inclusions is not known. A visual inspection (of the excavated area) indicates that the quality of the D-walls at Vijzelgracht Station is significantly worse than at Rokin and Ceintuurbaan, even though they were installed by the same contractor. The overall quality of the walls at Vijzelgracht is worse than might reasonably have been expected. The presence of so many large bentonite inclusions has led to doubts about the workmanship and quality control.

The bentonite inclusions are most likely caused by a combination of suboptimal circumstances during the installation of the walls, such as delays after removing the steel stop ends, after cleaning the bentonite slurry, the inclination of the stop ends and very thick reinforcement bars relative to the aggregate size of the concrete. Moreover the bentonite slurry had to be replaced entirely in several panels probably because of an unfavourable interaction with the soft mix. In addition, cleaning the trench with the 5.2m-wide panels from just one pump position and concreting with only one tremie pipe could have contributed to the development of a large bentonite inclusion. All the causes listed here mean that the trench was not fully cleaned with fresh bentonite just before concreting (Figure 1a). During concreting, the thick bentonite was therefore not removed by the concrete, as seen in Figure 1b. The result is a bentonite inclusion in the concrete, as shown in Figure 1c.

Figure 1: Creation of a bentonite inclusion during the concreting of a panel in three subsequent stages.

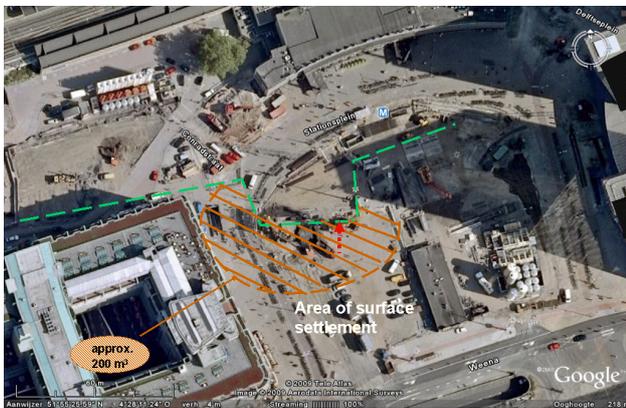
For the reconstruction of the metro station in front of the central railway station, excavation is required down to 14m below the surface. The retaining structure is composed of D-walls installed to NAP – 36m through soft Holocene clay and peat layers and the first medium to coarse sand layer (from NAP –17 to –33m) into a stiff clay layer. So, the D-walls function as cut-off walls. When the excavation had almost reached the required depth, water and sand started to flow into the pit through a joint. The flow was estimated to be 100m³ per hour and it lasted for more than a day. Outside the D-wall, pavement settlement started immediately. Ultimately, a roughly semi-circular settlement trough resulted measuring about 200m³. The sand that flowed into the excavation was most probably from the top of the first sand layer, some metres below the excavation level. Fortunately, there were no buildings in the immediate vicinity.

Figure 2: Surface settlement area

Once again, the exact cause of the bentonite inclusions in Rotterdam is not known. There were serious delays during the installation process, both at the panel with the major leak and at panels without any defects. So the cause was probably a combination of different conditions.

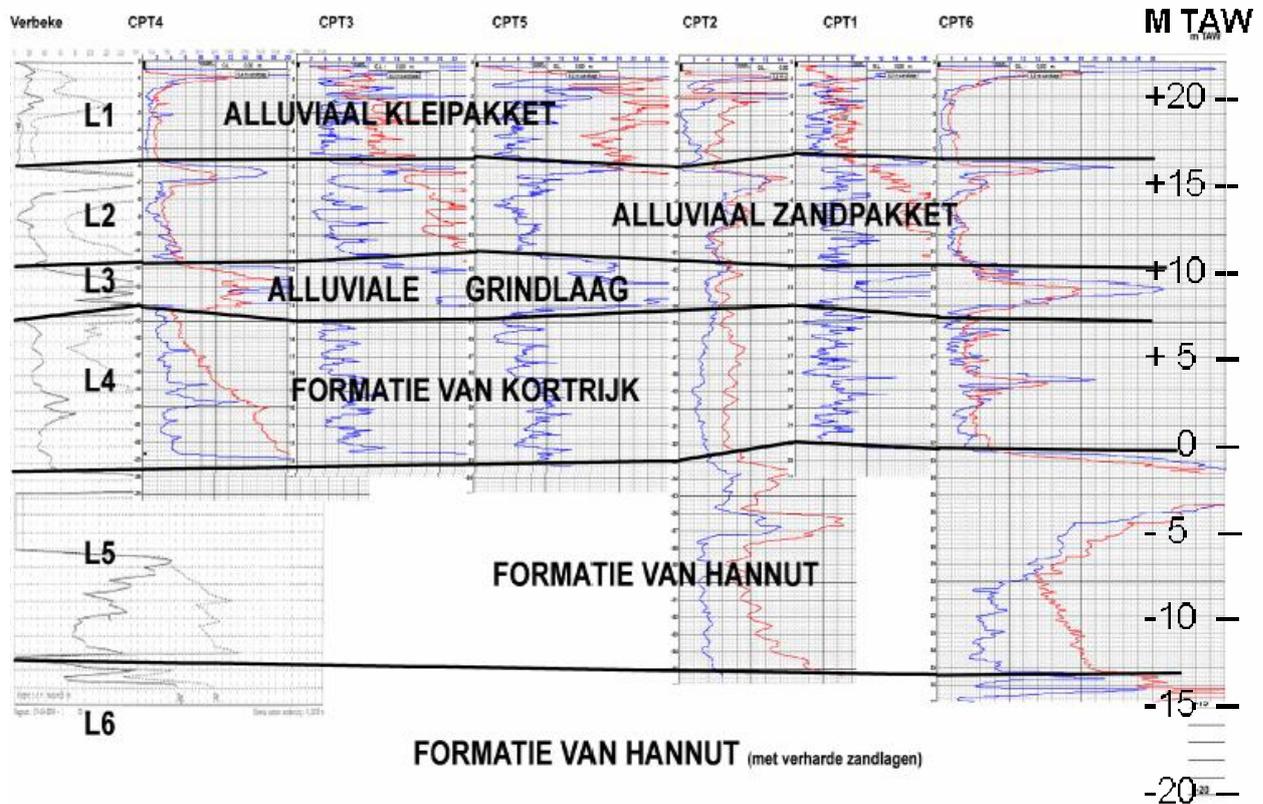
Figure 3: Soil profile at Vorst construction site

clear that the large amounts of water flowed through the clay layer, which everybody had thought was a horizontal hydraulic barrier (L4 in Figure 3). At present, it is still unclear how such large amounts of water could flow through the clay layer.

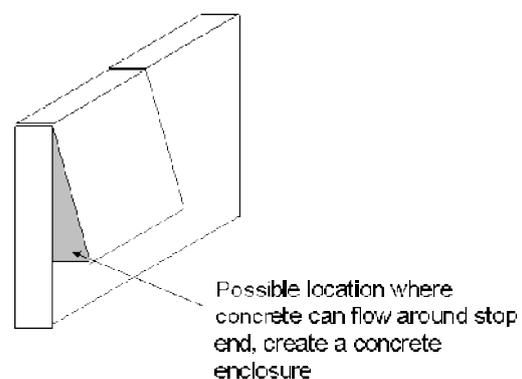
The type of grab is important. In deep excavations, hydraulic grabs with a hydraulic correction system are better because it is possible to compensate for the deviation by turning the grab. To check verticality, most grabs these days are equipped with inclinometers so that drivers can check verticality during excavation. Excavation should be as vertical as possible and a conservative approach to correction is required since corrections can further the development of enclosed concrete as well as excess concrete consumption. If a driver waits too long before correcting an inclination during the excavation, a kind of excavated wedge will be created, allowing concrete to run around the stop end, as in figure 4.

Figure 4: Effect of an inclined excavation corrected during excavation

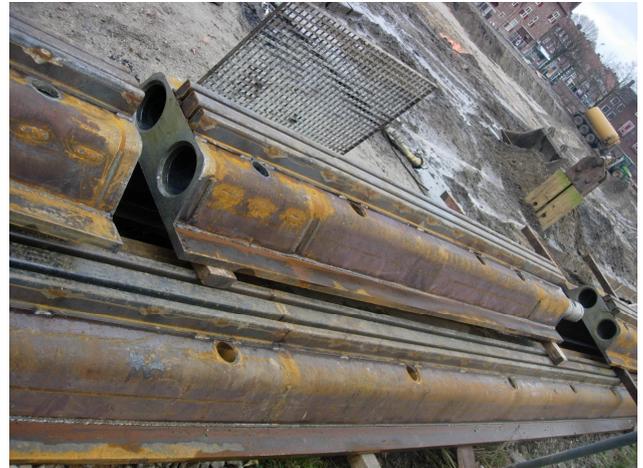
There are many types of stop ends used by contractors. The most common are the open-ended pipes and the CWS-type joint. The second is preferable because it allows for the installation of a water bar in the wall joints to provide waterproofing. The water bar is partly fixed in the CWS stop end and the other end is cast in the concrete, as shown in Figure 5. Moreover, this profile can guide the grab.

Figure 5: CWS type stop end with the groove for two water bars.

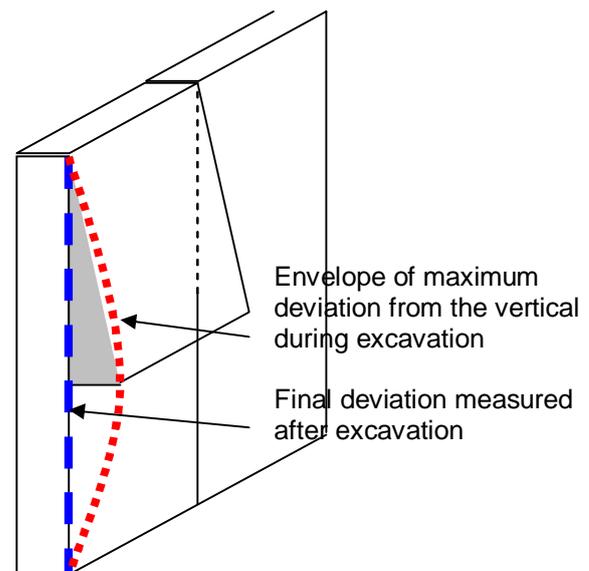
Drivers correct vertical inclination on the basis of real-time parameters. So it is advisable to present not only final verticality (in two directions) but also the range of the maximum deviations during the excavation process. There can be a considerable difference between maximum and final verticality, as shown in Figure 6.

Figure 6: Final verticality and maximum deviation from verticality during excavation
