Renovation of a lock by means of special techniques

ABSTRACT: At a lock for 1350 ton vessels on the Albertcanal at Olen, with regular time intervals of a few years measures had to be taken to avoid excessive settlements of the lock bottom slab and cracking and deformation of the walls. These measures consisted mainly of grout injection under the slab. Special techniques were used to solve the problems in a permanent way :

PROCEEDINGS OF THE TWELFTH EUROPEAN CONFERENCE ON SOIL MECHANICS AND
GEOTECHNICAL ENGINEERING/AMSTERDAM/NETHERLANDS/7-10 JUNE 1999

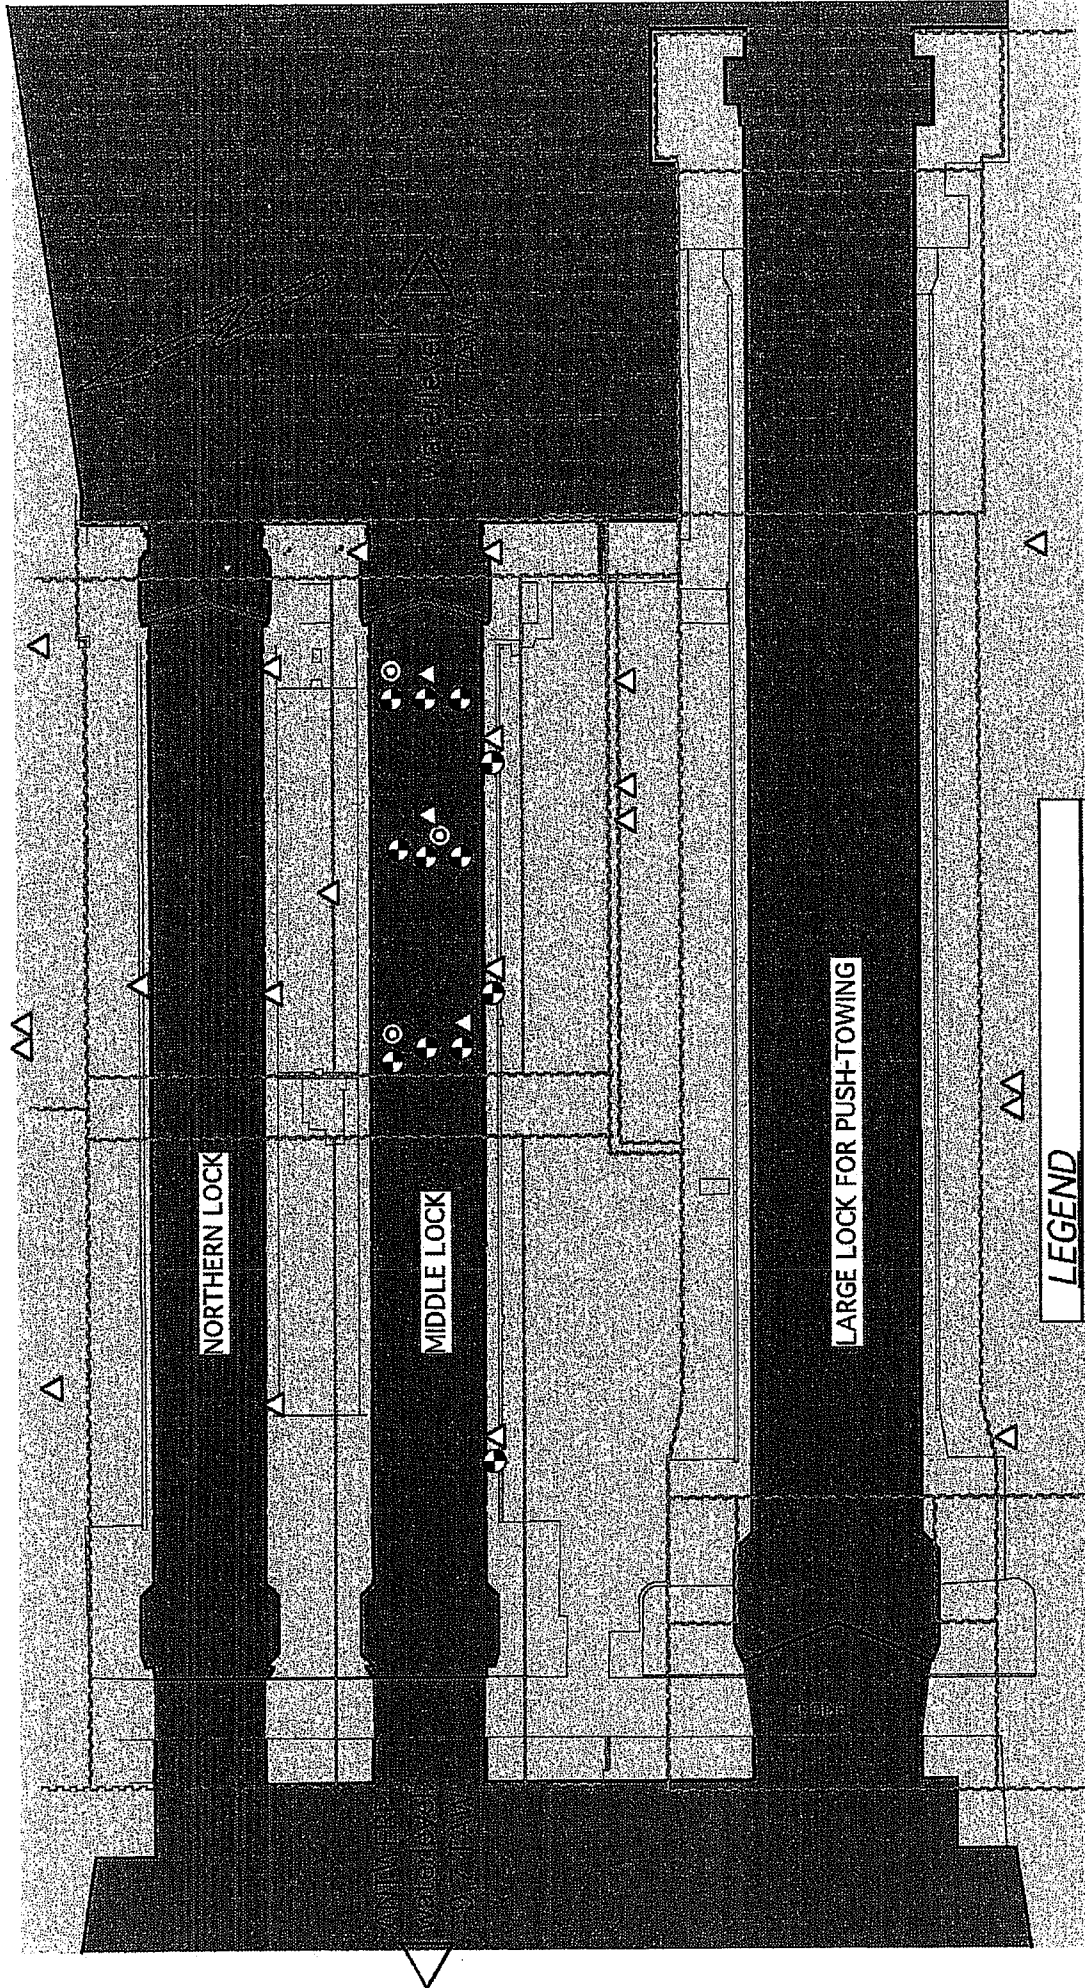
LOCK SITUATION OLEN

In figure 1 in annex a layout of the site is given. The lock under consideration is the middle lock. The soil investigation consisted of:

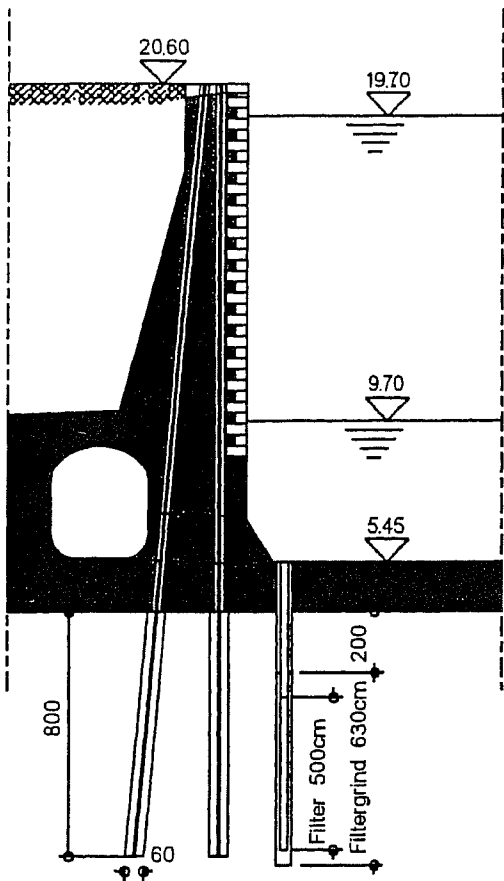
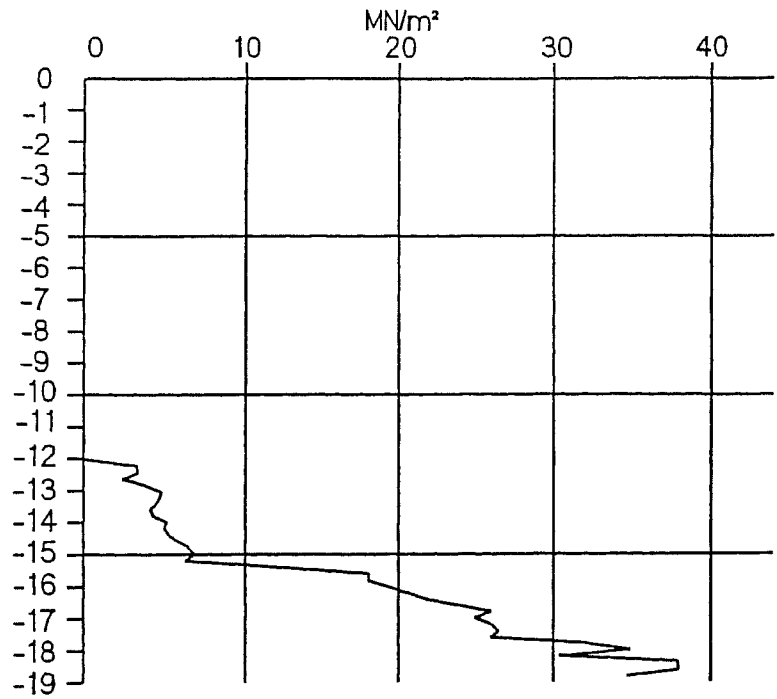
In figure 2 (top right) a representative CPT is given performed near the bottom of the lock. Figure 2 (lower half) also shows a representative seivng curve of the material under the lock. It could be concluded that the lock was built on heavy compacted sands showing cone resistances up to 20 Mpa.
