Renovation of the lock at Olen – Belgium

Some examples of the use of grouting techniques

ABSTRACT: The lock at Olen (Belgium) was built in 1938 and has a water level difference of 10 m. The lock showed severe damage caused by erosion of the sandy foundation layers, followed by differential settlements and general cracking of the lock structure. Remedial works were performed using various grouting techniques. As a first measure, the contact between the structure and the foundation layers was restored by means of low pressure grouting under the floor slab and under the lock walls. The stability of the lock walls was ensured by means of vertical tension bars that were anchored in jet grout columns. Further erosion of the foundation soil was prevented by means of a grouted upstream cut-off wall, combined with pressure relief wells under the lock. Despite the difficult situation for the grouting works in the lock partially in use and the fact that this project was the first to use the technique of the pressure relief wells in a lock structure, measurements of porewater pressure showed that the renovation works were successful. This paper will focus on the difficult situation in which

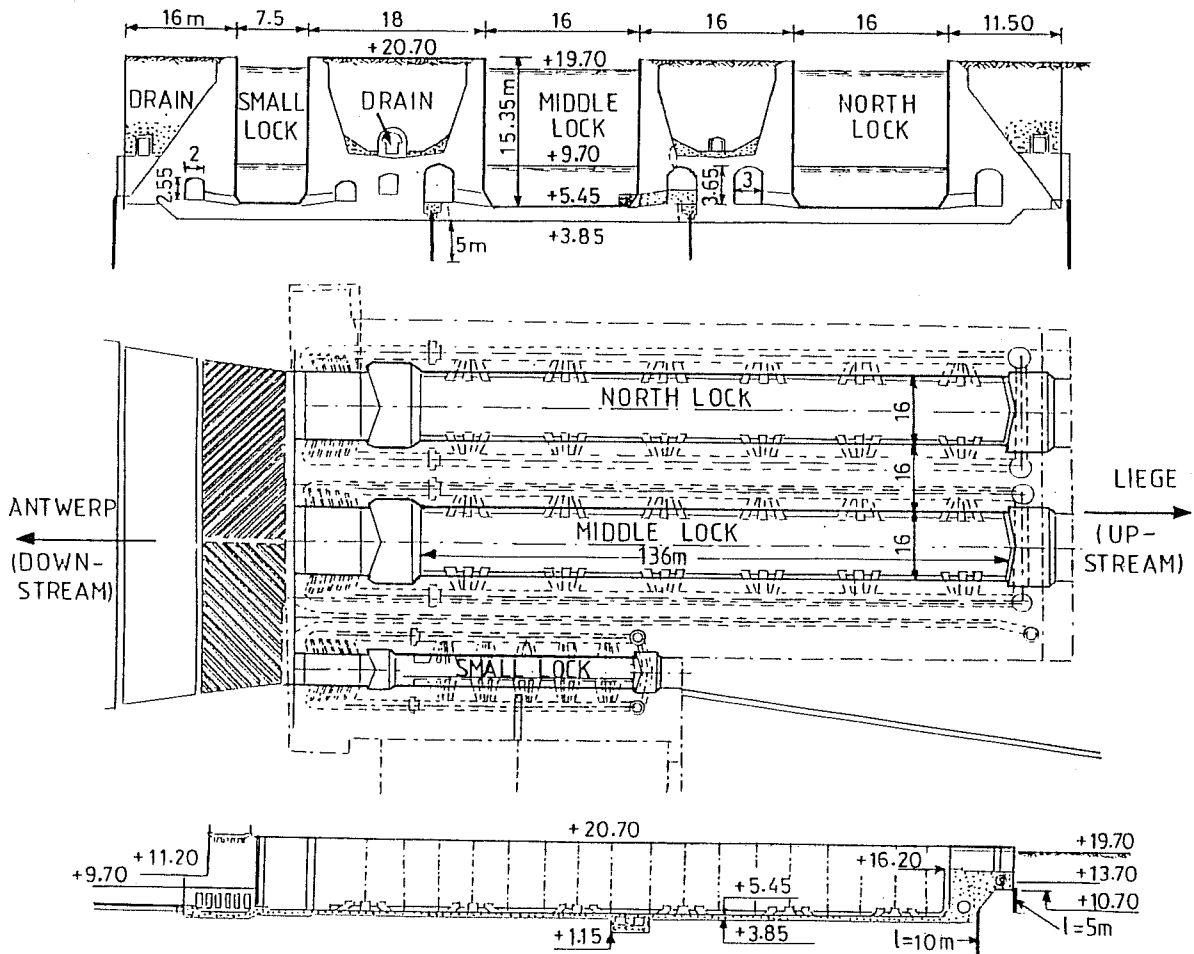
Figure 1. Cross section, plan view and longitudinal section of the locks

The Albert Canal in the Northeast of Belgium, connecting the river Maas with the harbour of Antwerp, was constructed between 1930 and 1939. Several locks with a water level difference of 10 m each had to be built. Each of these locks consisted of three side-by-side locks: two large locks with length 136 m and width 16 m and a smaller lock of 55 m and width 7.5 m. A sketch of the cross-section is given as Figure 1.

- the cut-off screens were too small and totally inefficient
- the three parallel locks were founded by means of one large jointless foundation raft.

These problems caused erosion of the sandy foundation soil and, due to the differential loading, cracking of the whole structure.

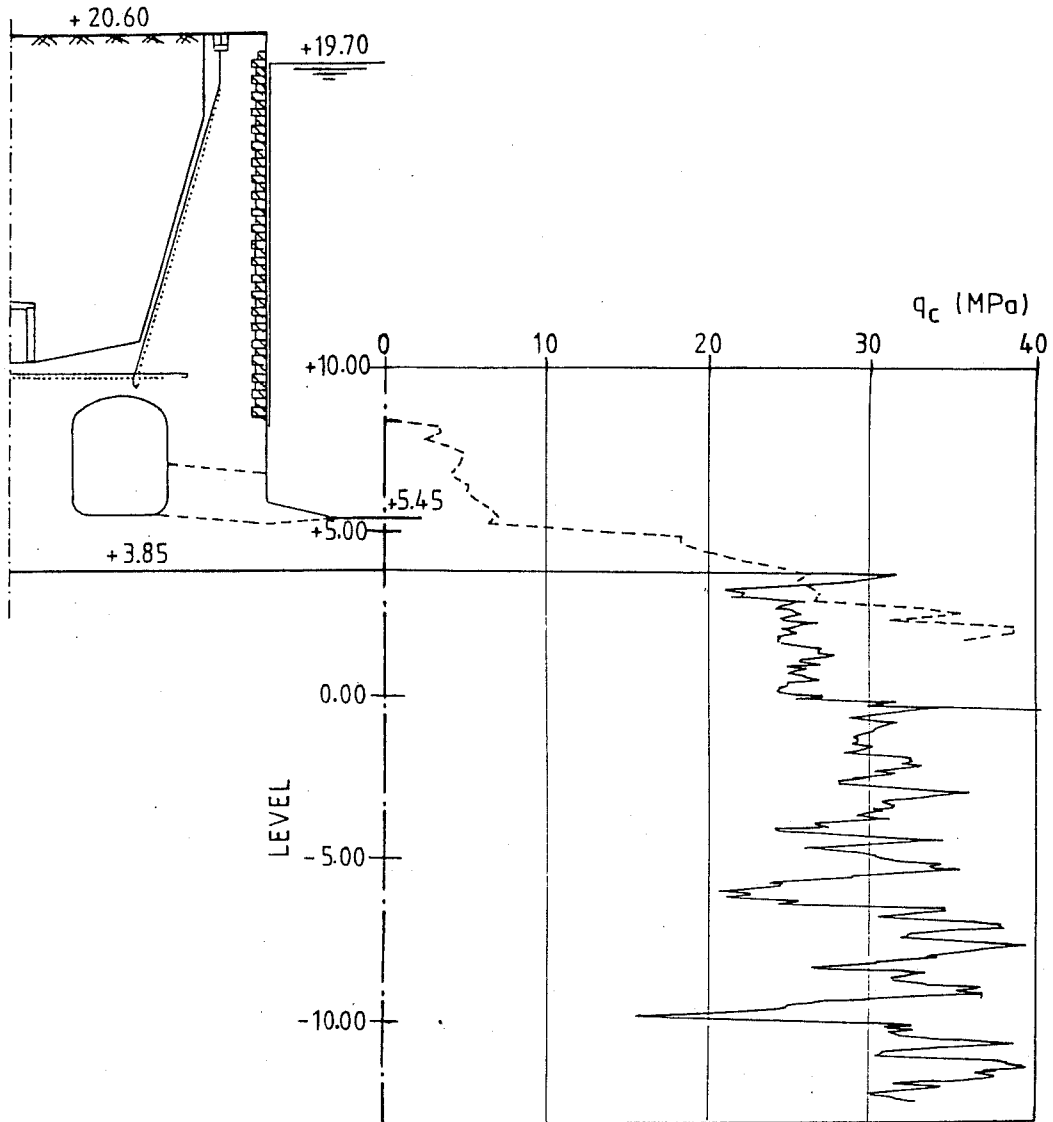
Figure 2. Typical CPT results. Full line: under the lock chamber; dotted line: under the upstream head of the lock.

A typical result of a CPT test and a sieving curve of the foundation sand is given in Figure 2 (full line) and Figure 3. The CPT test shows that the original undisturbed foundation layers consist mainly of well compacted sand with a total thickness of over 15 m and with cone resistance between 20 MPa and 35 MPa.

In the zone immediately under the floor slab sometimes holes or very loose sand was found, although this was not a systematic evidence. This is typical for an erosion problem that causes flow pipes which continuously enlarge.

Under the upstream head of the lock a more important layer of loose sand or disturbed sand was found as shown by the CPT result given in Figure 2 (dotted line). This layer has a thickness of about 6 m and could be the result of poor compaction during construction or of the important groundwater flow around this part of the structure.

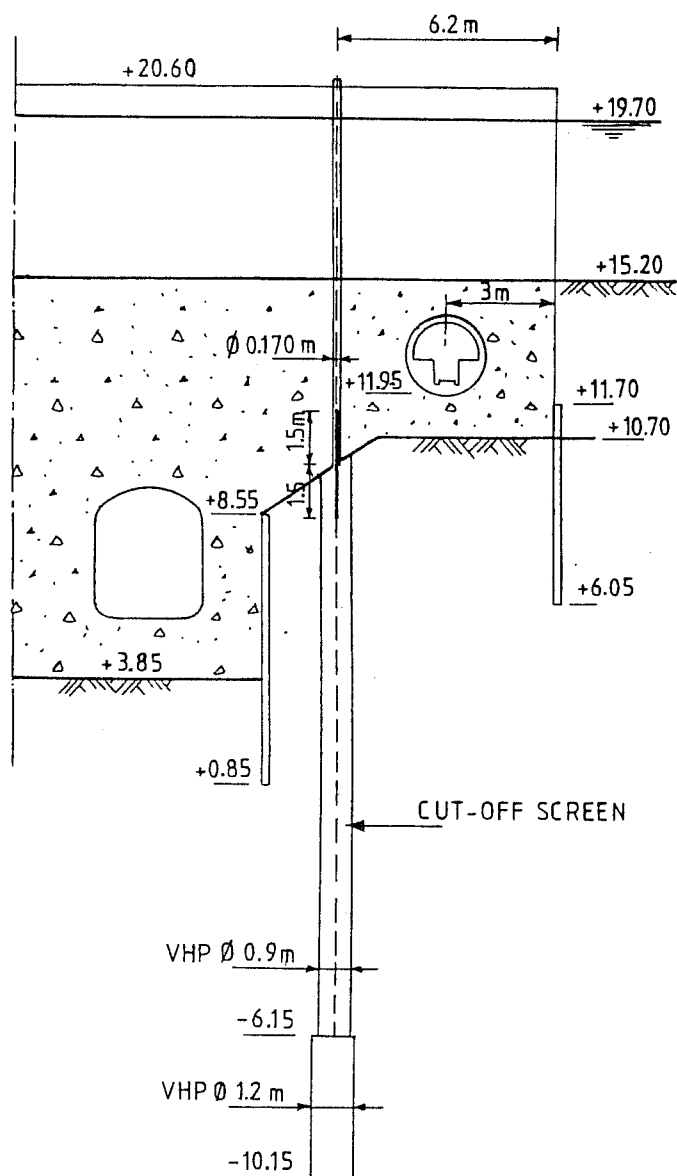
Figure 4. Longitudinal section of the upstream head of the lock

Only the injections under the upstream head of the lock were less successful. This was attributed to the fact that the bottom of the concrete structure at this place is inclined (Figure 4) and to the fact that possibly direct hydraulic connections existed with the upstream part of the canal.

The cut-off wall up to 14 m under the lowest floor level of the lock structure had to be executed under very difficult conditions. Figure 4 gives the longitudinal cross section of the upstream head of the lock. The position of the cut-off wall is indicated on this section. This position was selected as being the most appropriate. The borings through the concrete structure had to be very precise: verticality and position between conduits etc. The bottom of the concrete structure at this section is inclined, making the work even more difficult.

To avoid too much problems a maximum interdistance of 0.60 m of the grout columns was chosen. Since the watertight cut-off wall had to be performed with a single row of columns, the overlap between the secondary and primary columns had to be guaranteed. In order to create a

maximum diameter of the jet grout columns, the bi-jet grout technique was chosen. A diameter of 1.20 m is easily possible with this technique.

It was already pointed out that the soil conditions at this part of the construction were not good. Because of the loose compaction of the fine sand over the first 6 m the stability of the borehole could not be guaranteed when using bi-jet grouting. Due to the upward stream of air, the walls of the boring might collapse, with as a result poor quality grouting and possible holes in the cut-off screen.

To overcome this problem the first 6 m of the columns were performed with mono-jet grouting. At these depths the error caused by the eventually inclined borings were still limited and a diameter of the columns of 0.90 m was sufficient. These columns were made first. After a few days of hardening the bi-jet piles with a total length of 14 m were made through these mono-jet piles, underneath them.

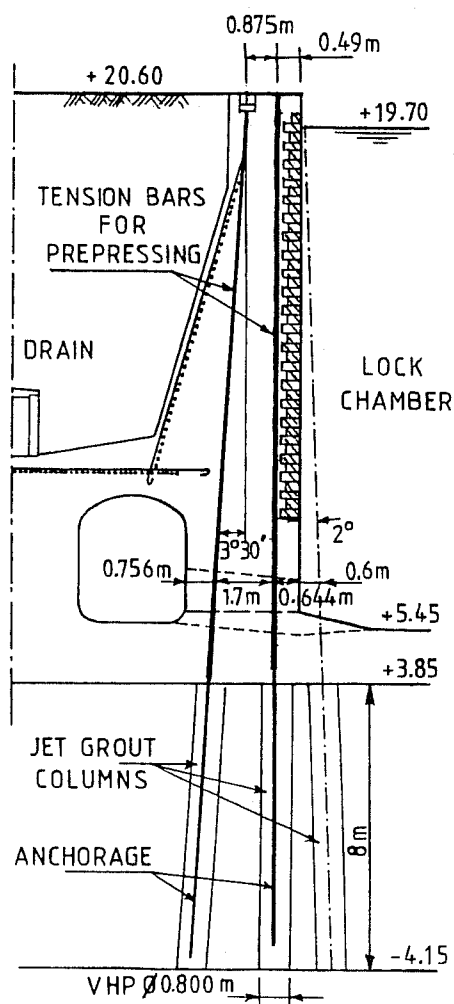
Figure 5. Cross section of the lock wall with jet grout columns

Figure 5 shows a cross section of the lock walls. Horizontal cracking could be seen at various levels from the top of the floor slab up to the head of the wall. Sometimes whole parts of the wall had moved towards the lock as one block. Movements up to some cm were measured.

To ensure a reliable foundation 3 rows of jet grout columns were executed underneath the walls through inclined borings. The piles reach to a depth of 8 m under the original foundation level, ensuring a bearing of the piles in undisturbed soil and sufficient length for the anchorage of the tension bars.

To restore the homogeneity of the walls, vertical prestressing was performed. The vertical tension bar needed to be anchored under the lowest horizontal crack in the structure, being the top level of the slab. As the thickness of 1.6 m of the slab was not enough for the anchorage of the tension bar, the jet grout columns were used to anchor the tension elements. In this way some of the jet grout column rows got a double function.

As the quality in terms of strength was the most important here and the diameter of the columns needed not to be more than 800 mm, mono-jet grouting was used. As quality control compression tests were performed on the grout mixture before injection, on the 'reflow' of the soil-grout mixture and on core samples taken from the hardened columns. Table 1 gives some representative results of these tests. As a lower limit, a characteristic compression strength $f_{ck} = 8 \text{ N/mm}^2$ was set as requirement. This value was reached in the majority of the tests (>95%). The sampling rate for quality control was: 4 samples of the soil/grout mixture and 1 core boring (2 samples) every 15 piles. Tests on the grout mixture were done only in the beginning to check the grout quality.
