Underpinning and consolidation of the foundations of St. Mary's Basilica at Tongeren (Belgium).

J. Maertens, Jan Maertens BVBA and KU Leuven

Keywords: Restorations, Underpinning, Masonry injection, Micro piles

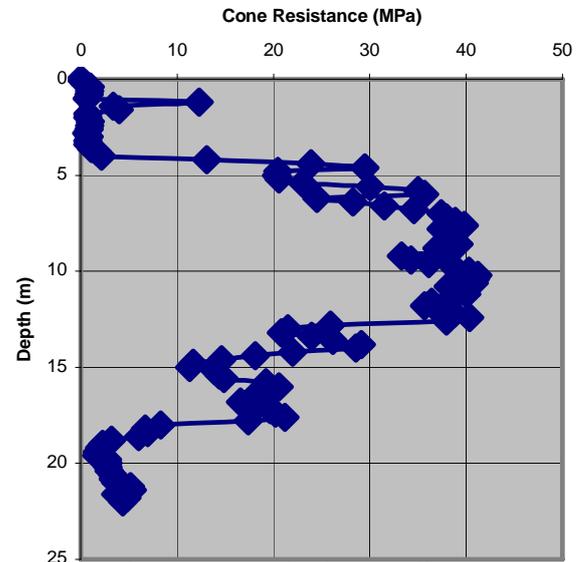
Figure 1: Typical CPT diagram

- filled and/or disturbed soil layers from groundlevel till 3 or 5m depth
- very dense tertiary sand layers ($q_c > 20$ MPa) till 15 or 20m depth

A typical CPT diagram is given on figure 1.

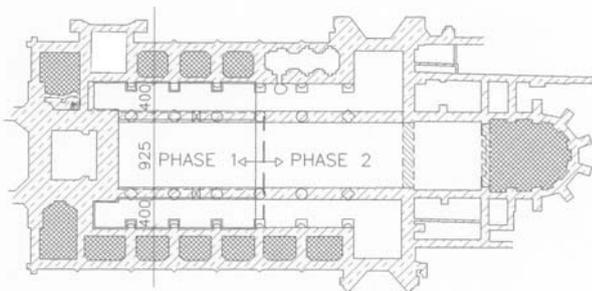
Figure 2: Plan of church with intended excavations

Figure 2 shows a plan of the nave, aisles and chapels of the church. The massive west tower is not represented. The first phase of the excavations is shown in the left part of the plan.

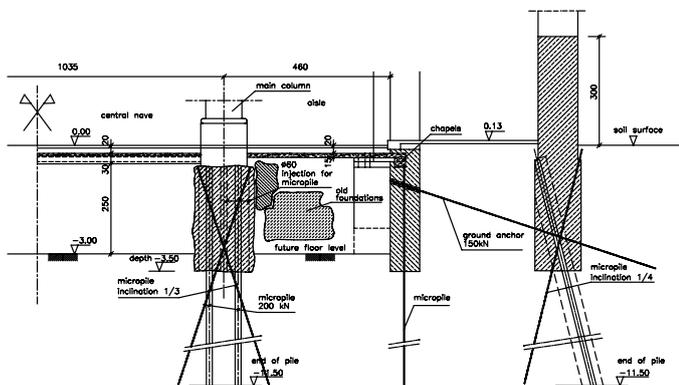
Figure 3: Cross-section of archaeological cellar

Figure 3 gives a cross-section of the archaeological cellar. The micro pile system under the columns and walls is also presented. The load bearing capacity of the micro piles is 200 kN pro pile. As can be seen also the exterior walls are supported by micro piles, although no excavation will be made next to these walls.

The underpinning of the columns and uncovered walls is needed because the strength of the foundation soil becomes insufficient after removal of the soil layer of about 3 m, representing a surface load of 50 kN/m². This heavy load will be removed over a large area of about 20 x 40 m, and by that the strength of the foundation soil drops drastically under the column footings and under the foundation walls. Also the stress distribution in the soil all over the church surface changes considerably, and as a consequence also the deformations of the soil will change. This might lead to excessive differential settlements of structural elements, leading to cracking of walls and vaults. The underpinning of all the columns and walls in and adjacent to the excavation will avoid such differential settlements.

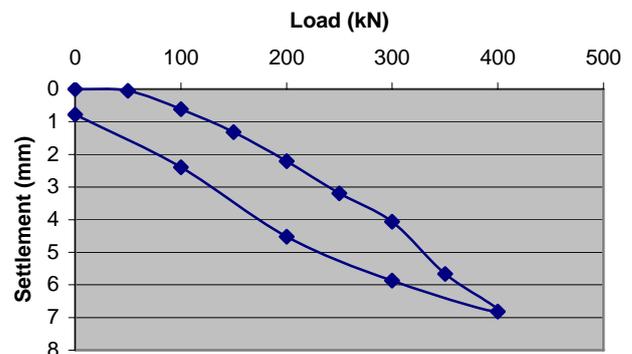
Figure 4: Maintained load test on a micro pile

In order to check the bearing capacity of the micro piles a preliminary load test has been performed on a micro pile installed outside the church. Over the upper 3m the load transfer to the soil has been eliminated by means of a PVC tube. The obtained load settlement diagram is given in figure 4.

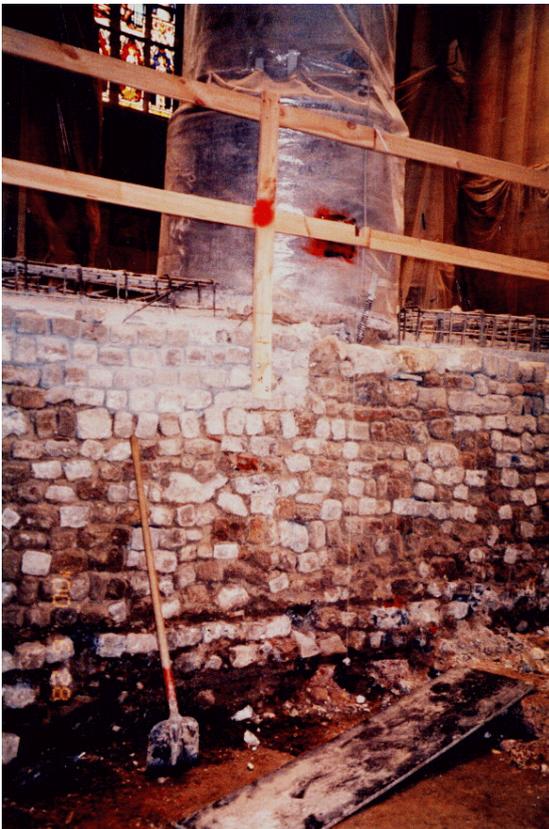
Figure 5: Chain wall between collars

The columns transfer a concentrated load of 1800 kN to the foundation footing. These footings are connected with a chain wall, as shown in Figure 5.

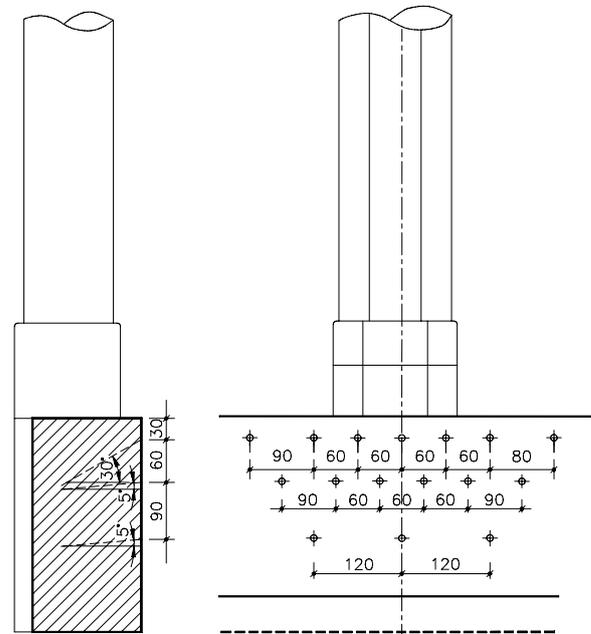
Figure 6: Cemented anchors in column foundations

The position of the columns on their footings and on the chain wall is mostly eccentric. This eccentric position introduces additional bending stresses in the masonry. The available strength of 3 to 6 MPa after the first injection is not reliable enough to secure the arising compressive and splitting stresses. Therefore, an additional strengthening is executed in the column foundations, Figure 6.

Three layers of cemented anchors with diameter of 25 mm are placed to take up the horizontal splitting forces caused by the concentrated column load. The layers are placed when the excavation reaches the corresponding depth. After drilling the anchor holes a second injection of the cement grout is made through these holes, to improve the consolidation of the adjacent masonry. The number of anchors per layer decreases with increasing depth.

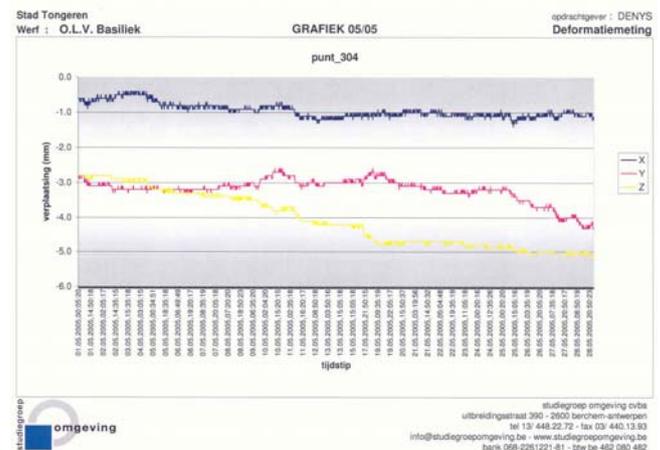
Figure 7: Observed settlements during the installation of micro piles (z = vertical direction, x and y = horizontal direction)

- settlements mostly occur during the installation of the micro piles, however not during the drilling into the ground, as is expected normally but during the drilling of the hole through the existing foundation. Also rather surprising was that destructive drilling with a down the hole hammer and by core drilling produced the same settlements. The total settlements of the columns due to the installation of the micro piles varied between 4 and 8 mm. An example of the displacements measured during the installation of the micro piles underneath a column are given in figure 7.

- underpinning of the chain wall foundation produced some settlements. However these settlements are mostly due to a rearrangement of the rubble stones within the masonry, and much less to the drilling into the ground;
- almost no settlements occurred during the excavations.

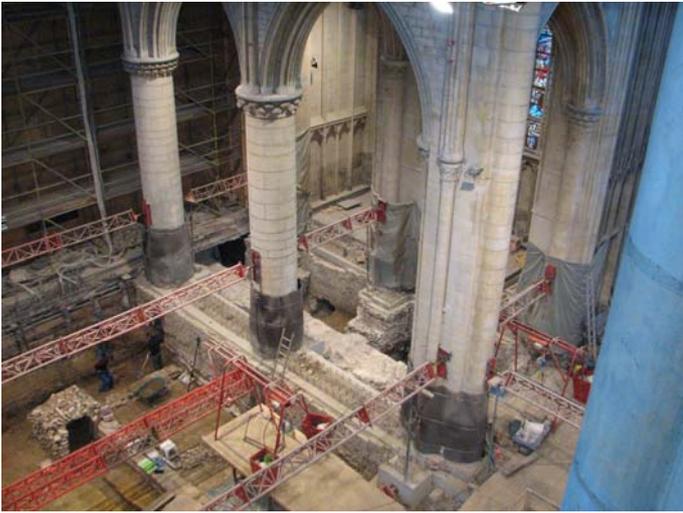
Figure 8: General view of the excavations

A general view of the excavations is given in figure 8.
