Effect of compaction grouting in loosely packed sand on density

H. Pachen *Rotterdam Public Works, The Netherlands.*

P. Meijers, M. Korff *GeoDelft, The Netherlands*

Prof. J. Maertens *Jan Maertens bvba & Cath. Univ. Leuven, Belgium*

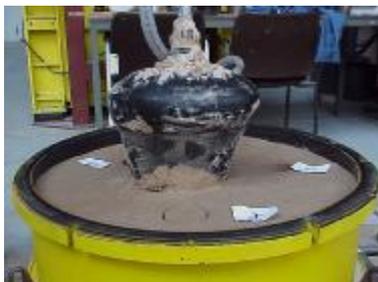
Partly excavated grout body after the test

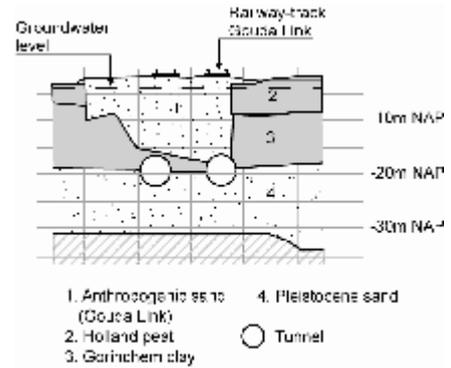
Cross section railway embankment with tunnel

The shield tunnel of Randstandrail (Rotterdam, The Netherlands) crosses the railway Rotterdam-Gouda

The railway embankment consists of anthropogenic saturated very loose sand

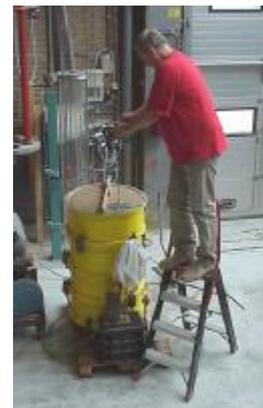
Execution model test

- cylinder filled with loose sand
- use of a balloon in order to contain injected volume (prevent occurrence of fracturing)
- no surcharge loading
- measurement of
 - injected volume
 - void ratio
 - cone resistance (with a penetrometer)

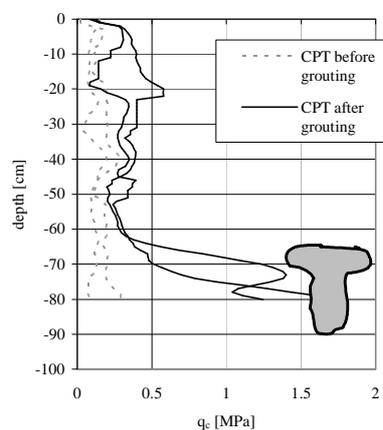
Measured cone resistance before and after the test

- contrary to general believe in this case no compaction but loosening
- increase in cone resistance
- increase in horizontal stresses expected
- increase in cone resistance does not prove increase in density

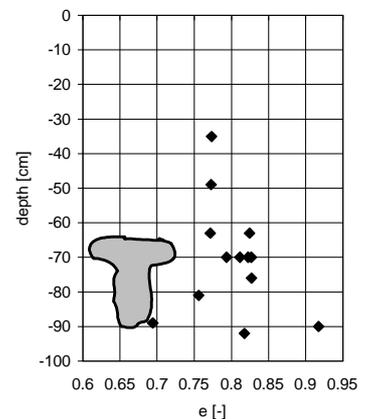
Measured void ratio after the test, initial void ratio $e = 0.77$
