Renovation of the lock at Olen – Belgium

Some examples of the use of grouting techniques

ABSTRACT: The lock at Olen (Belgium) was built in 1938 and has a water level difference of 10 m. The lock showed severe damage caused by erosion of the sandy foundation layers, followed by differential settlements and general cracking of the lock structure. Remedial works were performed using various grouting techniques. As a first measure, the contact between the structure and the foundation layers was restored by means of low pressure grouting under the floor slab and under the lock walls. The stability of the lock walls was ensured by means of vertical tension bars that were anchored in jet grout columns. Further erosion of the foundation soil was prevented by means of a grouted upstream cut-off wall, combined with pressure relief wells under the lock. Despite the difficult situation for the grouting works in the lock partially in use and the fact that this project was the first to use the technique of the pressure relief wells in a lock structure, measurements of porewater pressure showed that the renovation works were successful. This paper will focus on the difficult situation in which

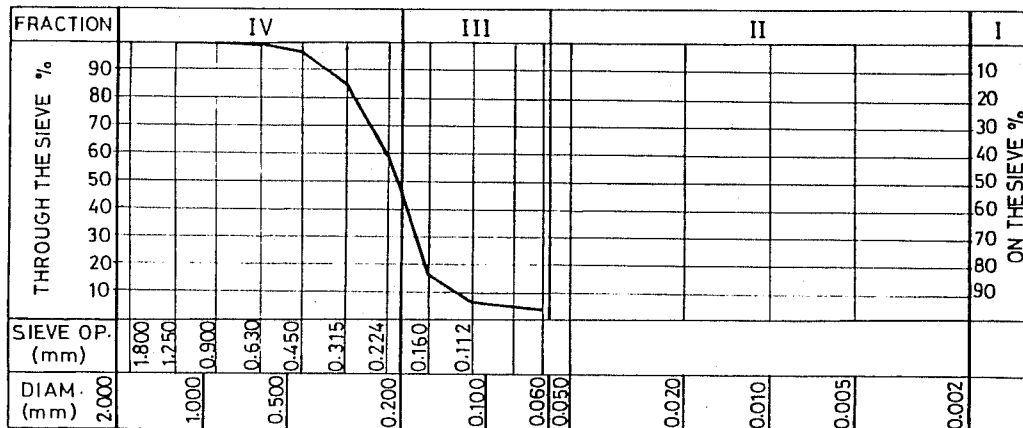
Figure 3. Typical sieving test result

A typical result of a CPT test and a sieving curve of the foundation sand is given in Figure 2 (full line) and Figure 3. The CPT test shows that the original undisturbed foundation layers consist mainly of well compacted sand with a total thickness of over 15 m and with cone resistance between 20 MPa and 35 MPa.
